BELLCOMM, INC.

SUBJECT: Corona in LM Communication
Equipment - Case 320

DATE: October 13, 1969

MEMORANDUM FOR FILE

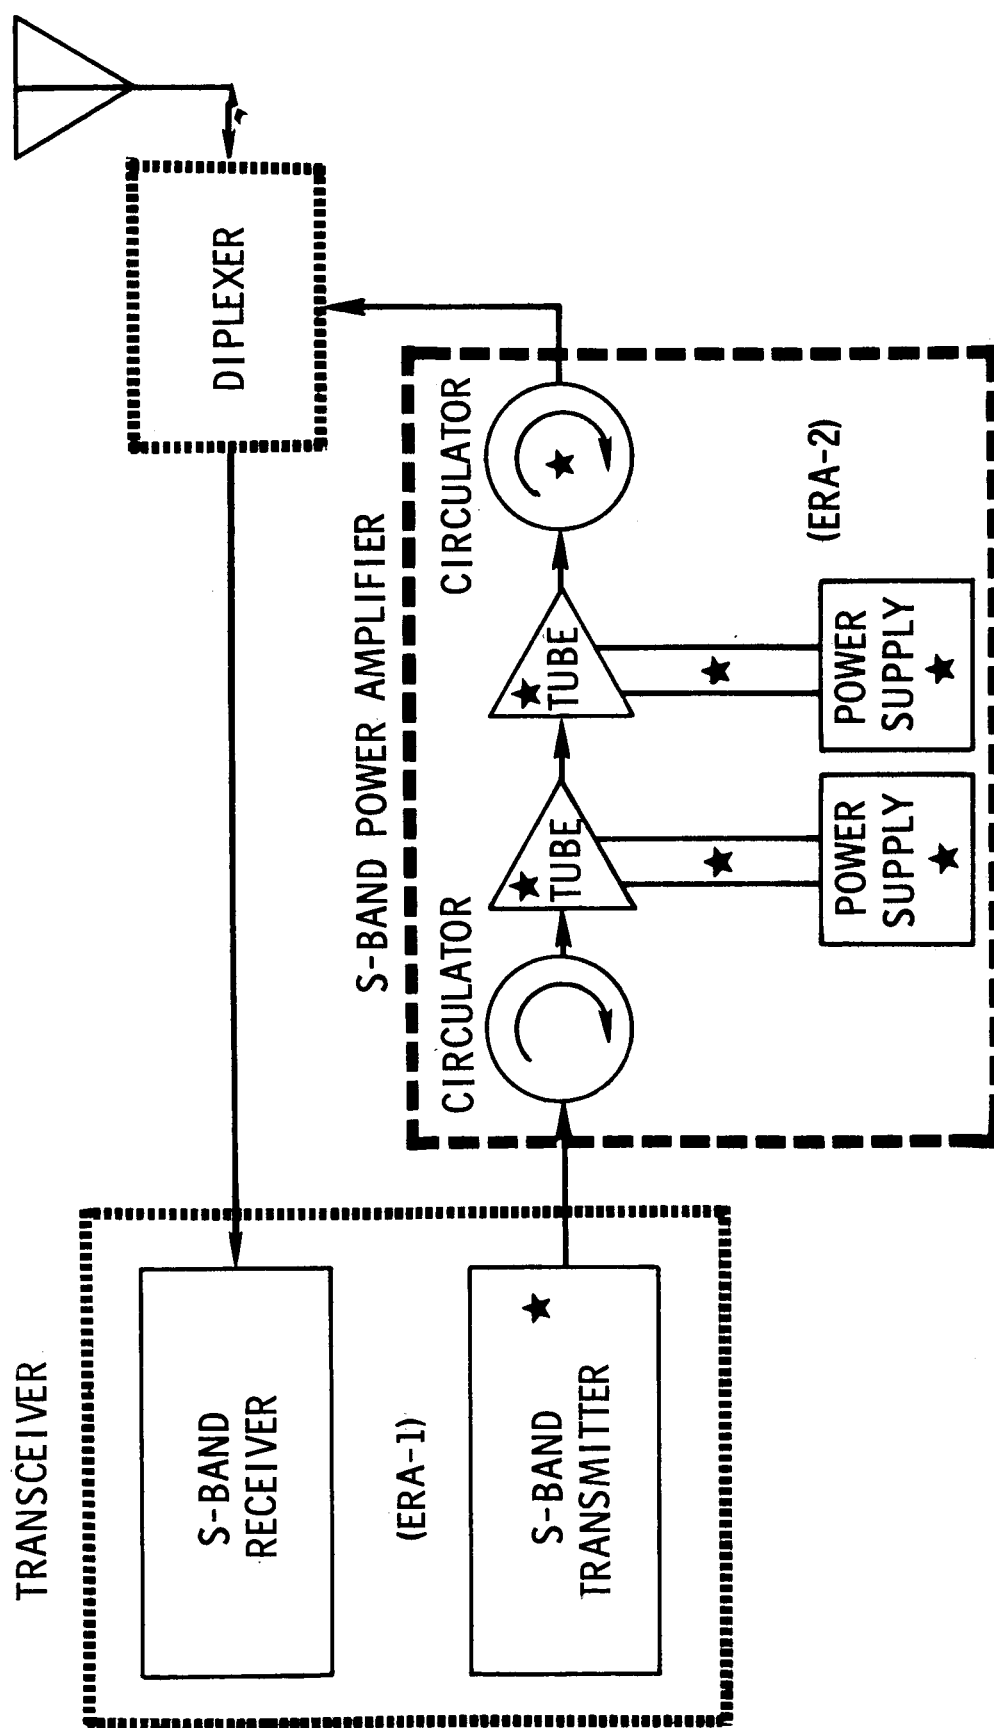
FIGURE 1 - LM S-BAND CORONA PROBLEM AREAS★
IN ELECTRONIC REPLACEABLE ASSEMBLIES (ERA)

Figure 1 illustrates where corona problems have existed in the LM S-Band communication equipment. As of November, 1967, the multiplier chain in the transceiver and the power supplies and circulator in the power amplifier were

exhibiting corona failures. The various fixes tried (primarily potting fixes) were not successful. Motorola had completed some work on the design and construction of a pressurized case which would completely enclose the S-Band Transceiver. Raytheon felt that further work in the potting-fix area would solve the power supply problem of the S-Band Power Amplifier. The circulator had already been redesigned to remove its corona problem. Raytheon agreed to follow a back-up approach which involved the design of a pressurized case for at least the power supply.

In January, 1969, Raytheon was directed to implement a pressurized case for the S-Band Power Amplifier and to install new circulators in the process. As of September, 1969, all S-Band Power Amplifiers had been built, tested, and delivered with no corona problems evident. The total number of units completed is sufficient to provide equipment through LM-15, plus two ERA spares and one module spare (components at sub-assembly level). This applies to both the S-Band Transceiver and S-Band Power Amplifiers.

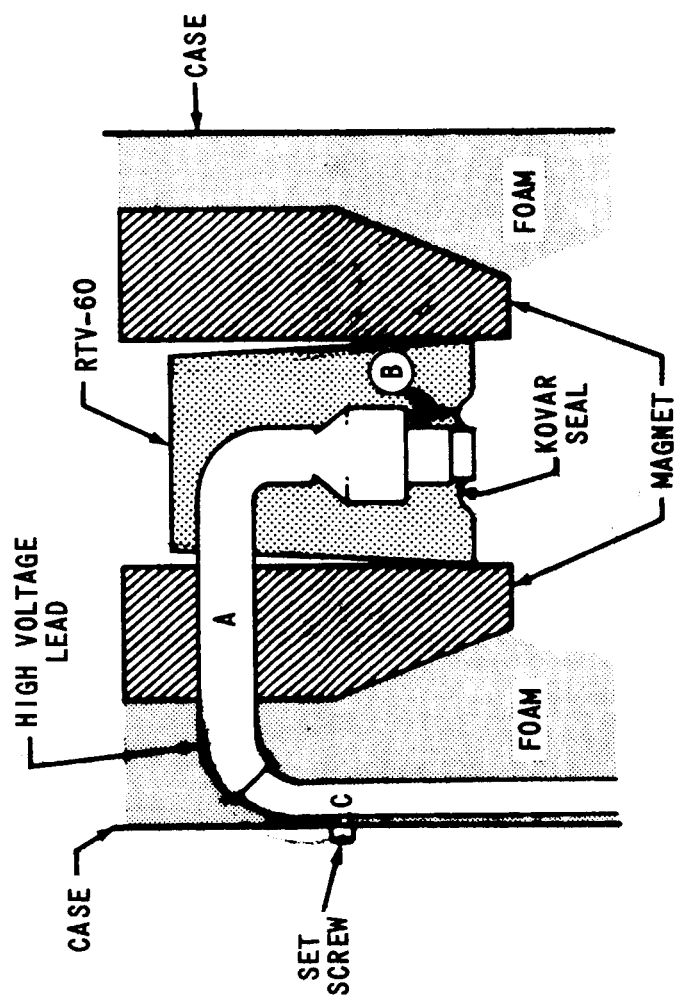
FIGURE 2 - ROUGH SKETCH SHOWING AREAS OF CORONA ARC OVER
IN THE AMPLITRON OF THE LM POWER AMPLIFIER

In May, 1968, Raytheon was directed to cease effort on the pressurized case design for the S-Band Power Amplifier (PA) since the potting-fix, with some redesign, had apparently eliminated corona in the power supply. However, in August, 1968, the amplitron tubes in the PA started to fail during thermal vacuum testing. Failures were traced to the high voltage leads within the outer case of the amplitron as shown on Figure 2 (Areas A, B, and C). Since failures had taken place in an area where the leads were potted in silicone rubber, several tubes were dissected to investigate the possibility of voids since the tubes were potted at atmospheric pressures. Voids were found and calculations on the amount of time required for a void to lead down to a critical pressure region indicated approximately 300 hrs. as the worst case. (Figure 9 illustrates how voltage breakdown varies with pressure).

AS A RESULT OF THESE AMPLITRON FAILURES (SN 258, 228, 200, AND SN 198) THE CCB AT MSC REQUESTED:

- 1) TESTS ON 16 REJECT TUBES IN EXTENDED THERMAL VACUUM
- 2) TESTS ON 2 REJECT TUBES AT VOLTAGES BEYOND NORMAL OPERATING LEVEL
- 3) TESTS ON 4 FLIGHT "ERAS" IN EXTENDED THERMAL VACUUM
- 4) RESUMPTION OF ERA CASE PRESSURIZATION WORK
- 5) BASED ON RESULTS OF ABOVE TESTING MAKE DECISION
ON CASE PRESSURIZATION IN JANUARY 1969

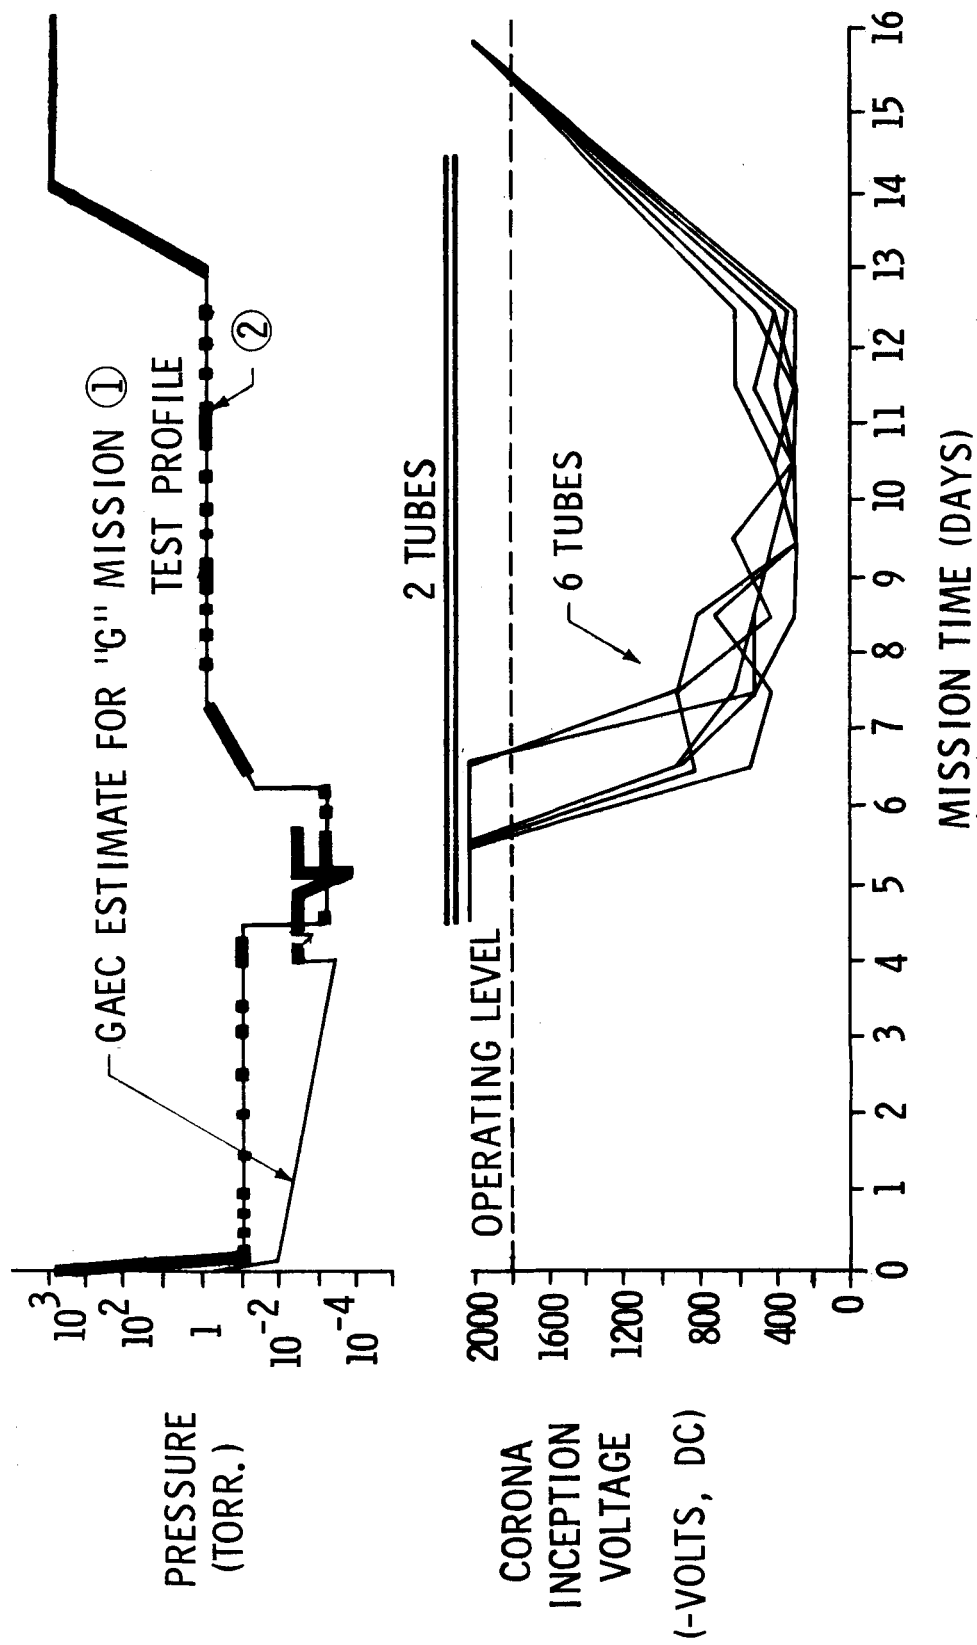
FIGURE 5 - TEST SUMMARY OF 8 AMPLITRONS

In November, 1968, it was decided that the work on the power amplifier case pressurization design, which had been terminated, should be resumed. A test program was also initiated to gain confidence in the power amplifier. Part of the test program would involve testing reject amplitron tubes for corona over an Apollo mission-type vacuum profile. These tubes had been rejected for reasons other than corona and, of course, were available. Figure 3 shows the basic test plan to be followed. Figure 4 provides a very brief summary of the test results, and Figure 5 singles out the test results obtained on eight reject tubes.* The corona inception level was

*Tubes were tested in groups of eight. Time scheduling prevented corona testing of the first set of eight tubes. In fact, the second set was not implemented until about four days into the test.

measured by gradually increasing the tube voltage (tube not operating) until corona was noted on an oscilloscope.

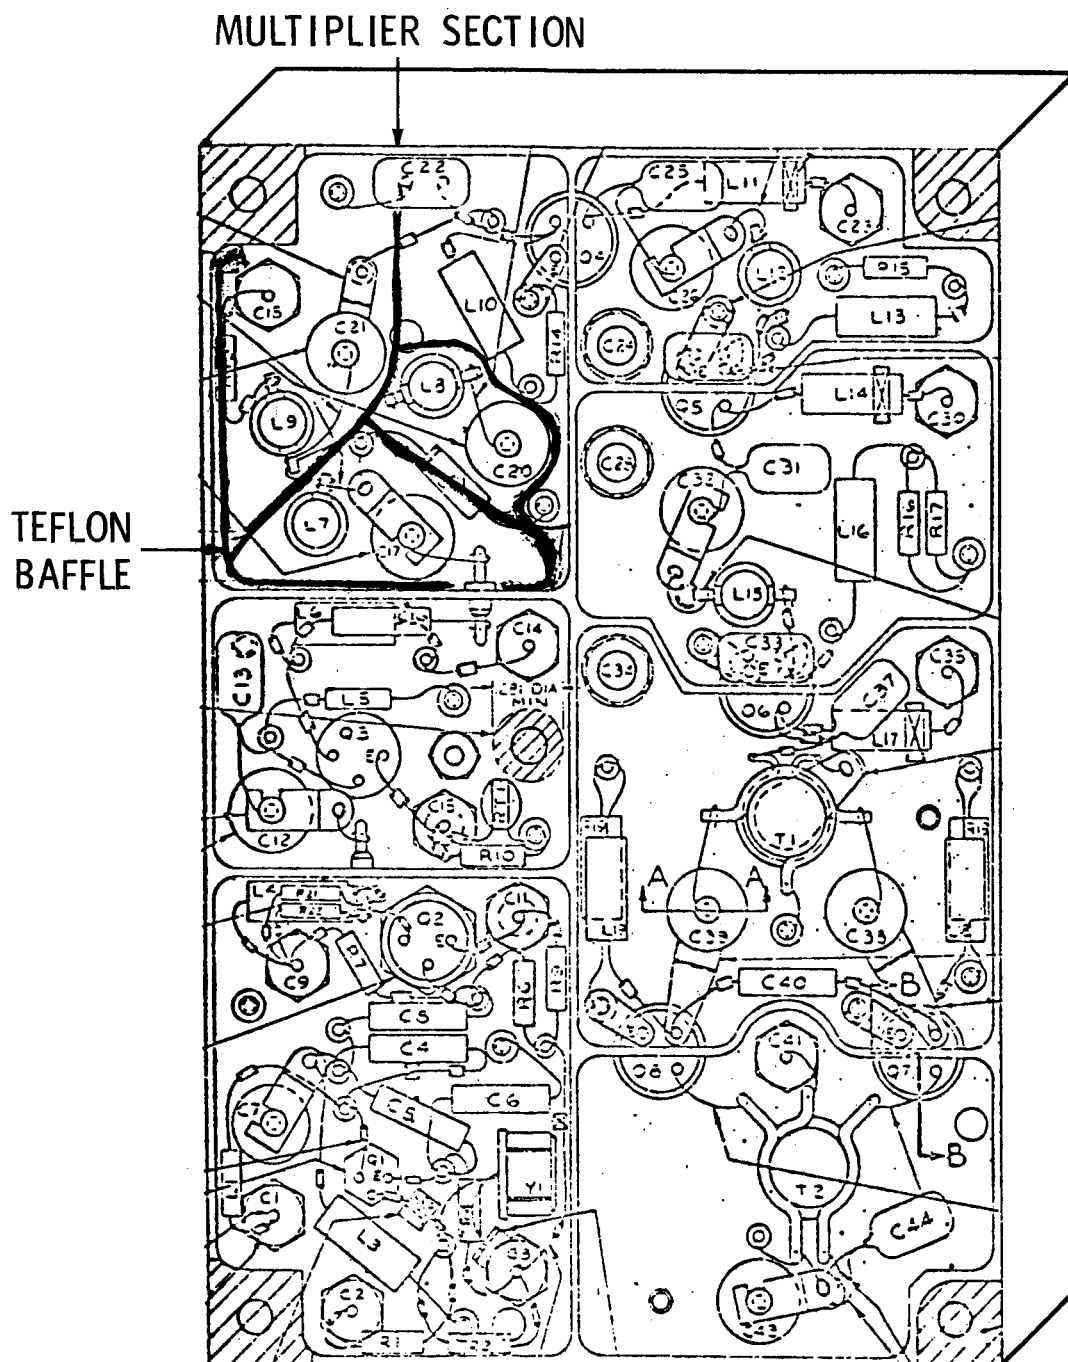
FIGURE 6 - TEFLON BAFFLES IN EXCITER
POWER AMPLIFIER SUBASSEMBLY

Corona problems in the VHF Transceiver had apparently been solved (as of November, 1967) by installing teflon baffles between the vulnerable components as shown on Figure 6. Subsequently, RCA pursued a crash program to add a VHF ranging capability to the transceiver. In March, 1969, Mr. Pajak of NASA/ MSC sent the author the data given in Figure 7 and asked for an opinion on the possibilities of corona still remaining in the VHF Transceiver. In the writer's opinion, no conclusion could be drawn since both pressure and temperature were varied simultaneously. By early May, 1969, thermal vacuum testing on SN-113 was underway at RCA. After reviewing data from these tests, the author concluded that the variations on Figure 7 were due to temperature and inaccuracies in instrumentation set-up.

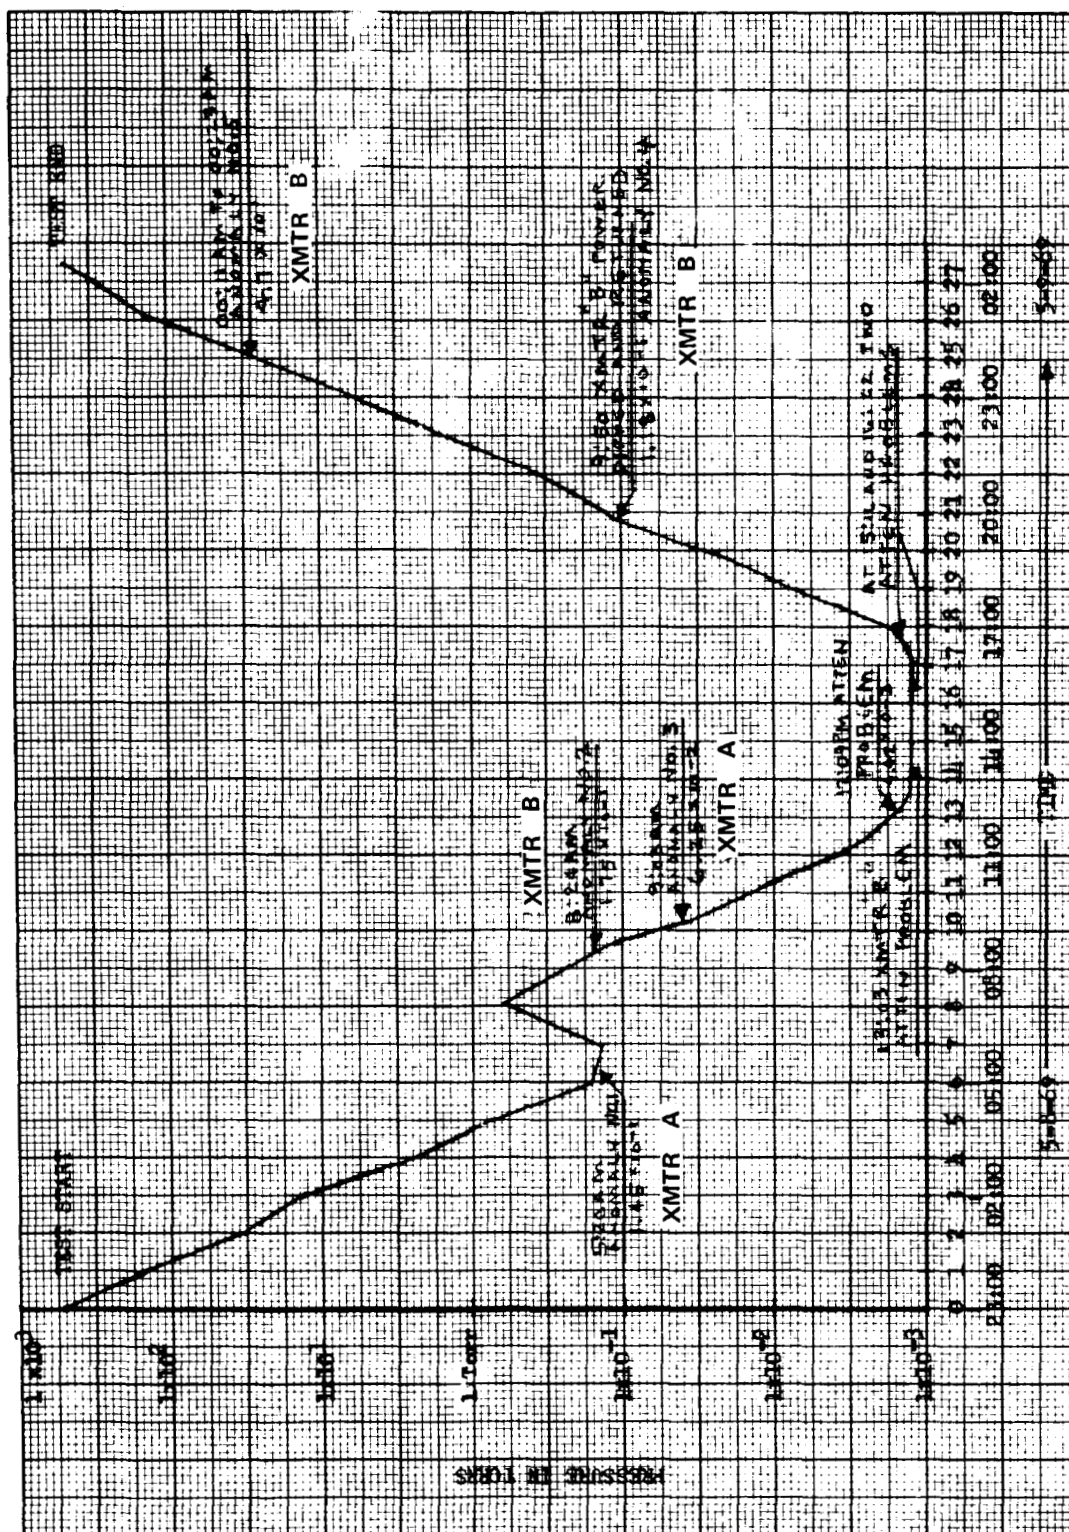
FIGURE 8 - PRESSURE VERSUS TEST TIME S/N 113

During the May 7, 1969, test, the power output of transmitter "A" suddenly dropped to about one-half its normal value. In the subsequent switching, cable changing, etc., the power of transmitter "A" returned to approximately its normal value. The author then recommended that the pressure be gradually increased and then decreased to see if the phenomenon would repeat. Figure 8 shows this recycle of pressure and the sequence of events which followed. A new attenuator was installed for transmitter "B" when problems were noted for a pressure near 10^{-3} Torr, but transmitter "B" showed further power changes as the unit was being brought up to atmospheric pressure. Additional details of these tests are included in RCA Test Report, "Substitute Thermal-Vacuum and Corona Tests LM VHF Transceiver Assembly," LTR-P-4270-7, 28 May 1969. Following the thermal vacuum testing of SN-113, the unit was disassembled to a level where most of the components could be seen. The author personally examined every accessible component under a microscope and could find no positive evidence

of corona. The author then asked Mr. R. Lang of Bell Laboratories to also examine SN-113 and his conclusions were the same. Other representatives present also examined the components with negative results. Of course, corona could have occurred in several areas where disassembly was not practical. Additional vacuum tests were performed on SN-113 at the module level with no indication of corona.
